## PROBLEM PREVENTION

**Autocoat BT**

## Problems

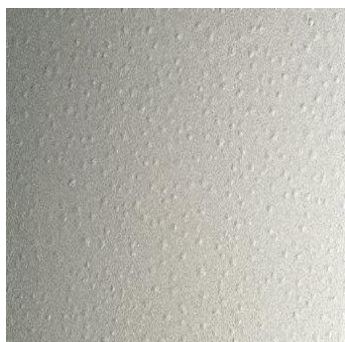
### 3. Blistering

The surface displays small pimples, either spread out or in groups. The blisters occur under the topcoat between one of the underlying layers. If you open a few pimples carefully, you can see for yourself the layer in which the blister originates. Blistering is caused by moisture or contamination under the paint which forces the car's paint system up. This normally occurs after a longer time period.

Contamination was left on the substrate before application	Always degrease properly before application
	Contamination caused by the hands of the applicator. One of the most underestimated risks during the repair process is finger or hand prints on the surface of the car. Because of perspiration, hands are covered with salt that will stick on surface	Do not touch ready to spray panels with bare hands. This kind of contamination can only be removed by rinsing with water and soap, or by using Waterborne Degreaser.

Wet sanding of the Polyester Bodyfiller. Absorption of water / moisture into the polyester product.	Always dry-sand Polyester Bodyfiller

Chalk and/or salt deposits from "contaminated" sanding water remained on the substrate, absorbing moisture, which will be trapped in the new paint film	Rinse substrate thoroughly with clean water after wet-sanding and thereafter dry the object completely

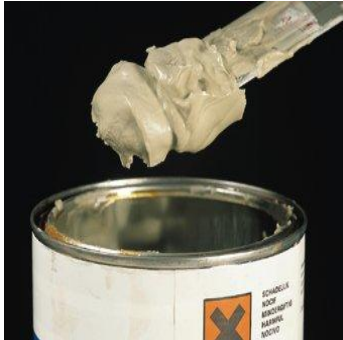
## 5. Bodying

If paint bodies, gelatin or thickens, it is often the result of solvent evaporation. One-pack products are particularly susceptible to this.

Process	Cause	Prevention
	Stored at too high temperature	Ideal storage temperature is around 20° C.

Bodied paint, primers and fillers are no longer suitable for usage and must be replaced with new ones.

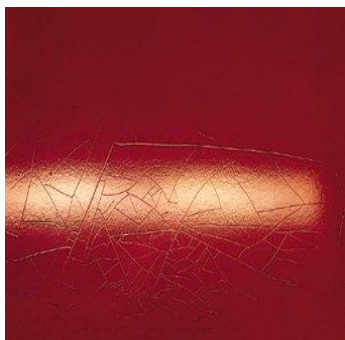
## 7. Hairline Cracks

After some time, a wide spread pattern of very fine hairline cracks appear in the paint surface. These will eventually develop into cracks that run straight through the paint layers.

Topcoat sprayed over a surface that has already cracked	Inspect the substrate carefully during degreasing.

Topcoat applied over too thick base layer. Topcoat is sprayed too thickly	Avoid over-application and keep within maximum layer thickness. Spray the recommended number of coats and use the correct spraying technique to avoid excessive application.

Remove the cracked paint film completely to sound layer and apply the system again.

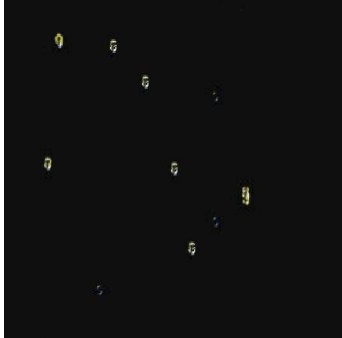
## 8. Chipping

A small piece of the finish seems to have broken away from the substrate.  
Sometimes the underlying filler coat has broken as well.  
This problem is usually caused by stone chips.

One of the paint layers has poor adhesion to the substrate or the top layer is too hard for the underlying paint layers.	Use the correct paint system for the substrate in question.
	Polyester Bodyfiller applied over Etch Primer  No recommended primer applied	Apply Polyester Bodyfiller only over bare metal or Epoxy Primer.  Apply the recommended primer / filler (aluminum, plastic, galvanized steel) when needed.

Touch up small areas before corrosion has a chance to damage the substrate. Touching with a small brush and paint should be carried out as soon as possible after the damage occurs to avoid rust and minimize the risk of further paint coming loose. More extensive damage will require preparation and re-painting.

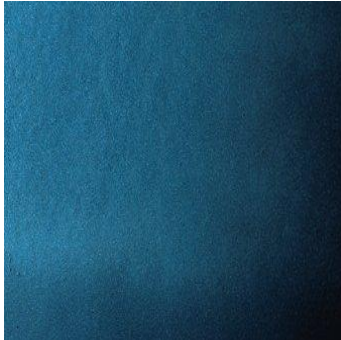
## 9. Cloudiness

Cloudiness appears in metallic / pearl basecoats only. Disorientation of aluminum / pearl pigments in the basecoat are causing a visible disturbance in color appearance (lighter / darker spots), known as cloudiness or mottling effect.

Too fast thinner selected so too fast evaporation of the thinner	Select the correct thinner related to temperature, size of repair and airflow.
	Incompatible thinner not qualified for the product selected.	Only select the recommended thinners for the products according to Technical Data Sheet.

Wrong spray-gun setup and incorrect air-pressure	Use recommended fluid tip and check air-pressure.
	Too heavy application of basecoat.	Apply according the recommended spraying technique.
	Flash-off time too short.	Allow recommended flash-off times and if necessary extend them.
	Poor overlaps	Use the correct spraying technique
	Mist-coat after too short flash-off time or at excessive pressure	Make use of the correct technique for the mist-coat.

Sand the surface with P500 dry or P1000 wet and re-spray according to recommendation.

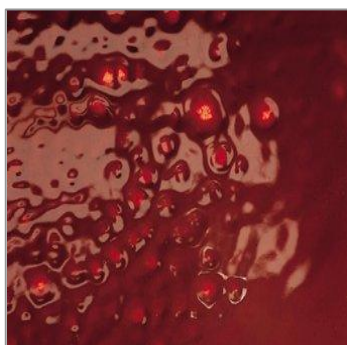
## 10. Craters

The surface is dotted with small local holes. Silicone craters form. The substrate is sometimes visible in the bottom of the crater.

The vehicle has not been degreased sufficiently	Degrease the object thoroughly before application. Use the proper degreaser.
	Dirty clothes have been used for degreasing.	Only use clean cloths for degreasing using a wipe on, wipe off technique.
	Using unqualified degreaser	Use recommended degreasers only.

Compressed air contaminated with oil and water.	Check oil / water separator and drain if necessary.
	Poor housekeeping, dirty working area.	Keep working area clean and free from contamination.
	Spraybooth contaminated with silicones	Don't use products containing silicone in the Spraybooth or in the workshop
	Use of silicon containing car maintenance and repair products in the mechanical department	Don't use products containing silicone in the workshop
	Poor maintenance, soot of oil heater.	Check heater and heating system regularly.

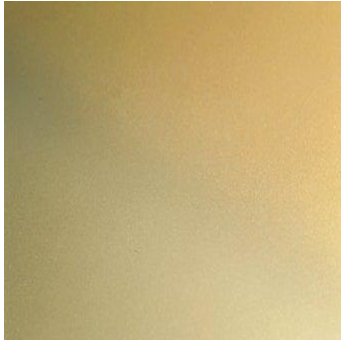
## 12. Color Difference

The color shade of the repaired area does not match the car's original color. Sometimes we can see flotation in the fresh paint finish.

Incorrect hardener or thinner used.	Select only recommended hardeners and thinners for the product according to Technical Data Sheet.
	Incorrect mixing ratio.	Mix the components as mentioned in the Technical Data Sheet. Changing the mixing ratio influences the color.
	Wrong spraying viscosity.	Use the recommended mixing ratio. If necessary check by using a viscosity cup.

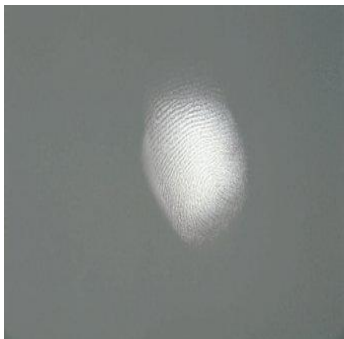
### 13. Poor Through-Hardening

After a considerable length of time, the paint film or polyester bodyfiller has still not hardened. You can easily make a mark by pressing the surface with your fingernail.

Hardener was left open for a long time and reacted with moisture. Hardener exceeds shelf life.	Keep hardener can or tube closed when not used. Notice shelf life of the hardener and keep track on expire date.

Wrong hardener selection.	Select recommended (sometimes dedicated) hardener.

Dry the object for a longer period at the recommended temperature. When insufficient through-hardening is the case, remove total system and apply again. When wrong products have been selected, remove the paint by washing off with thinner or by sanding and re-spray again.

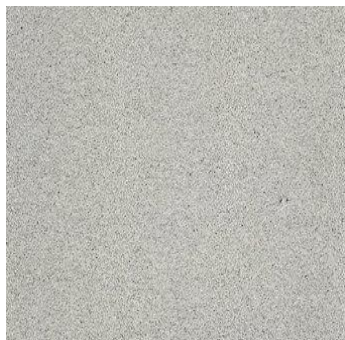
## 14. Overspray

Overspray falls on a freshly sprayed surface and is no longer absorbed. The surface acquires a sandy appearance because of the dry paint particles sticking to it.

Wrong hardener / thinner selection. Too fast hardener, paint film is closing too fast. Too fast thinner, paint film is closing too fast; a too fast evaporation, resulting in too much atomization (spray-mist).	Select recommended hardener / thinner related to temperature, job size and air-flow.
	Spraying viscosity too high due to insufficient thinning.	Use the appropriate measuring stick to get the correct mixing ratio.

The spraying pressure is too high.	Reduce the spraying pressure, as mentioned in Technical Data Sheet, to the recommended level.
	Spraying motion is too fast or spraying distance too far off.	Adjust the spraying technique and spraying distance as recommended by Technical Data Sheet.
	Wrong spray-gun and/or setup.	Use the correct spray-gun and setup in relation to the product to be sprayed.
	Spray-gun is dirty and/or poor maintained.	Use a clean and proper spray-gun.

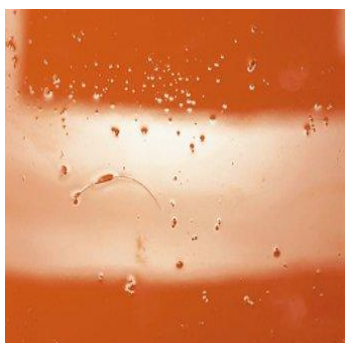
## 15. Dust Inclusion

Dust particles have fallen onto the wet paint film and became trapped as the paint film dried.

Clean before application, scuttles, wheel arches or gaps. Dirt and dust can blow up out of these areas.	Clean thoroughly all openings around the repair.

Paint contaminated.	Always make use of a paint strainer to filter out contamination
	Clothing creates dust.	Wear clean, fiber free, anti-static spraying overalls (nylon).
	Too much movement (walking) around the car causes dust to be thrown up.	Don't make unnecessary movements in the booth.

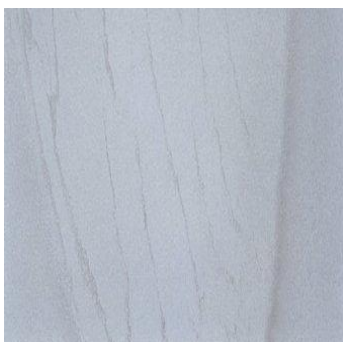
## 16. Flotation

Most colors consist of combination of different pigments. Each pigment has its own specific gravity. The lightest pigments will float to the top of the wet paint film. This process can affect the final color.

Too slow thinner type used.	Use the recommended Sikkens thinner.
	Too heavy application. The subsequent coats have been applied after too short flash-off time.	Avoid over application of each coat. Allow sufficient flash-off times.

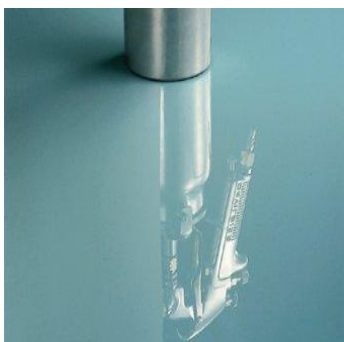
## 17. Low Gloss

The freshly applied paint has a lower gloss level than wanted.

Wax or similar contamination has been absorbed by the wet paint film.	Washing and degreasing the repair area and its surrounding thoroughly before sanding and painting.

Insufficient through-hardening of the filler before sanding. Sanded with too coarse grade of abrasive.	Pay attention to the drying time in relation to the ambient temperature and film build. Use only recommended sanding grades as specified in Technical Data Sheet.

Too fast thinner used. Wrong hardener and/or thinner used. Wrong quantity of hardener and/or thinner added. Components not properly mixed.	Select the correct thinner related to the repair size, temperature and air flow. Use the recommended Sikkens hardener and thinner. Use the measuring stick to achieve the correct mixing ratio. First add hardener, stir it and then add the thinner and stir again.
	Air drying one-pack topcoat polished too soon.	Refer to Technical Data Sheet for hard-dry to polish times.

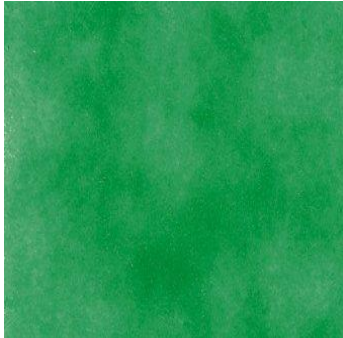
The substrate is visible through the topcoat. This usually occurs on surfaces that are difficult to spray or on angles and edges.

Apply the recommended number of layers or spray until covered.

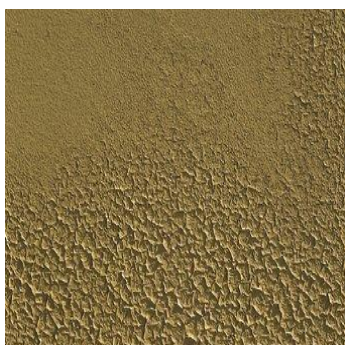
## 19. Lifting

During spraying, the substrate is partially dissolved.

The paint being applied is incompatible with the substrate.	Always carry out a substrate diagnosis around the area to be repaired.

The degreaser is too aggressive in relation to the substrate applied on (primer, filler and/or topcoat).	Check substrates and use the recommended products for that substrate.

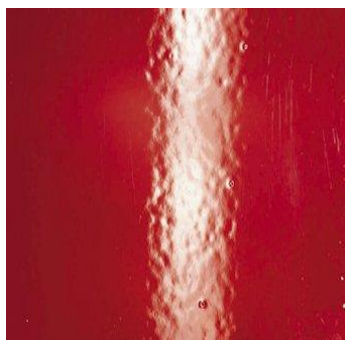
The freshly applied paint exhibits poor flow and resembles orange peel.

Paint spraying viscosity too high	Mix in the correct ratio using a measuring stick. Check viscosity.
	Wrong hardener too fast. Wrong thinner, too fast.	Select the recommended hardener for the job. Select the correct thinner in relation to job size, temperature and air flow.

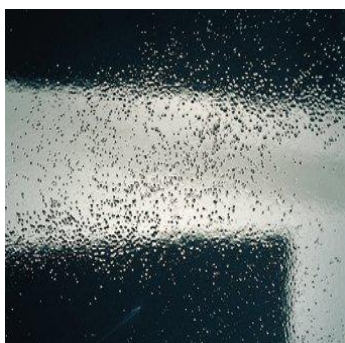
## 21. Pinholes

Small holes of around 0.5 mm diameter can be observed in the paint surface. If the hole is enlarged a little with a pin, we can see the paint layer in which the hole is originated. Air has become trapped in during application. After sanding open the hollows, causing small holes, the subsequent paint film has flowed into them.

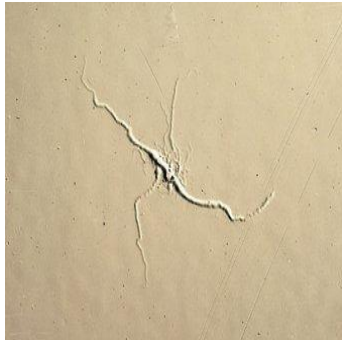
## 22. Rust

The paint system has been forced up over small areas, in strange patterns or as blisters. If we puncture them we discover rust and damp on the metal.

Application of topcoat directly over bare metal.	Always apply the recommended system for optimal warranty.

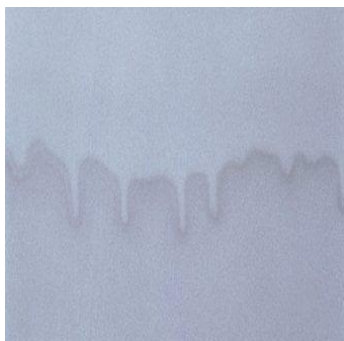
## 23. Runs

Through uneven thickness of the coat in some places, runs can be seen, mainly on vertical surfaces. The accumulation of paint in the area is so great that the paint coat starts to run while still wet.

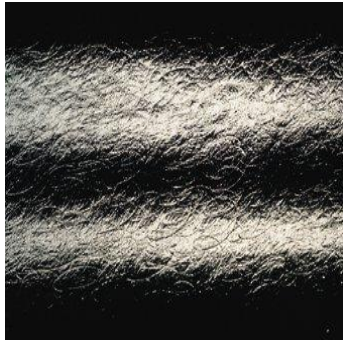
## 24. Sanding Marks

Fine scratches can be seen in the paint coat, generally the topcoat. The problem can reveal itself either immediately or after a few weeks. We can often recognize the sanding pattern of the sanding machine or hand sanding block.

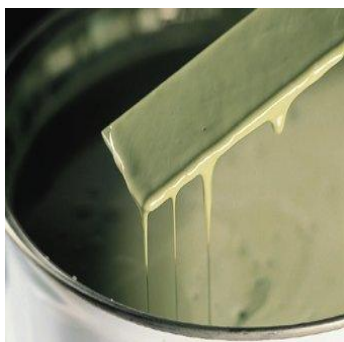
## 25. Settlement

If stored for a long time, certain pigments can sink to the bottom of the can due to their weight or shape. The paint is then no longer a homogeneous mass.

Process	Cause	Prevention
	The temperature in the storeroom is too low or the differences in temperature are too big.	Ideal storage temperature is around 20° C. and should be reasonably stable.

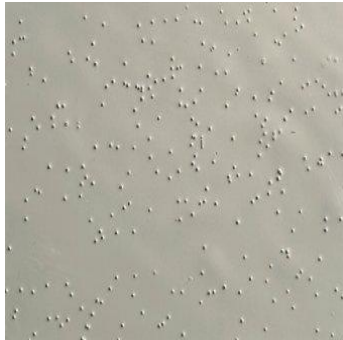
## 26. Solvent Pops

Small “pops” can be seen on the freshly dried surface.

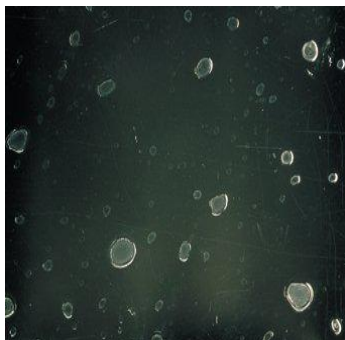
## 27. Water Marks

The edge of evaporated water droplets can be seen on the paint.

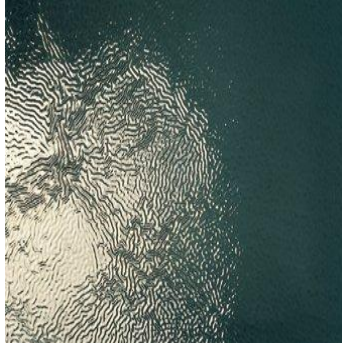
The paint surface acquires a finely waved appearance.

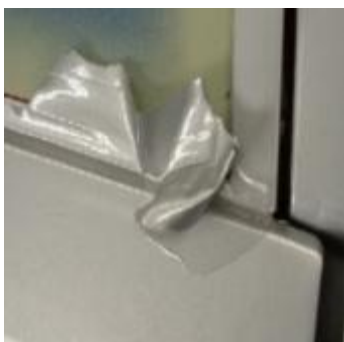
## 29. Peeling

Poor adhesion of the clearcoat may show immediately after application and drying of the paint, but it may also develop after some weeks or months.

Process	Cause	Prevention
	Wrong application technique, mist coat applied too course. No tacking between the layers.	Apply according to recommendation. Tack between every base coat after flash-off.
